Sticky Wickets

Working to Solve Pelton Governor Instability At John Day Dam

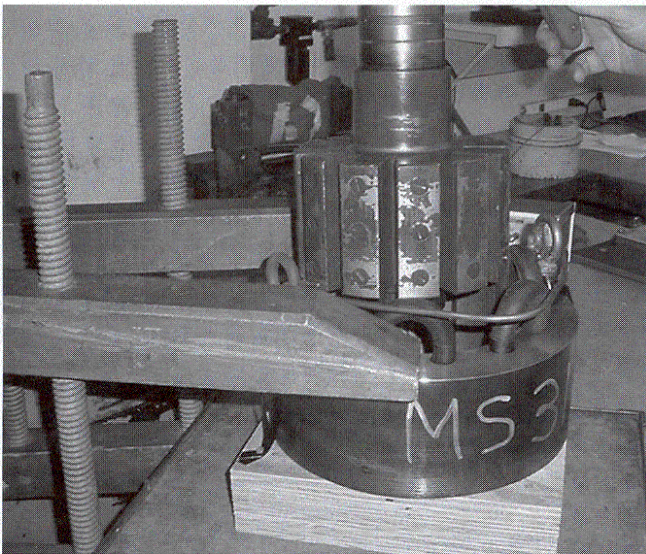
This rotor from the permanent magnet generator (PMG) of a Pelton governor from 2,160-MW John Day Dam is being remagnetized using direct current voltage. Remagnetizing the PMG temporarily solved a 14-year problem of governor instability on this unit.

Electricians measured the PMG output voltage and found it to be about 10 percent below normal. However, they noted that a few other Pelton governors at John Day were operating normally with similarly low PMG voltages. Because none of the PMGs at John Day had been remagnetized since their original installation in the mid-1960s, the electricians agreed to send the PMG from Unit 3 to be remagnetized.

At its repair facility, American Governor mounted the Unit 3 PMG on its PMG test stand and determined that output voltage was 14 percent below nominal. While this result was within Woodward tolerances, the documentation provided for the Pelton PMG explicitly cautioned against PMG output voltage more than 10 percent below nominal.

American Governor concluded that this PMG would indeed need to be remagnetized. But there was a problem. Woodward PMGs are remagnetized using alternating current (AC), whereas the Pelton design requires direct current (DC). American Governor worked with a magnetization expert to design a cus-

tom fixture and apparatus to supply short bursts of high-current DC. After several bursts, the PMG output voltage was restored to within acceptable limits. American Governor re-assembled the PMG and shipped it back to John Day. Because Unit 3 was already in operation, the Corps decided to reinstall the PMG during the next available scheduled outage.
