Governor Oil Pump Condition Assessment

By Alan Fox, American Governor Company

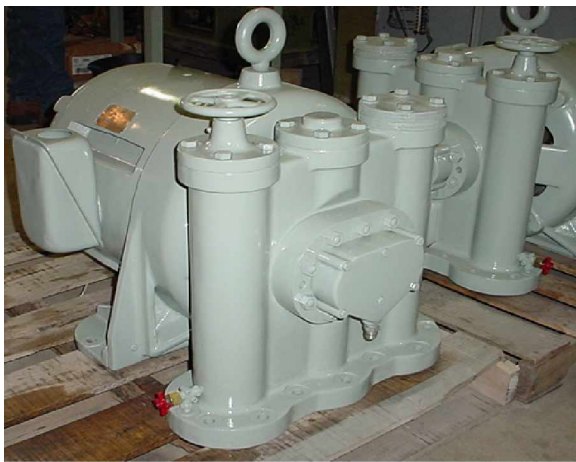
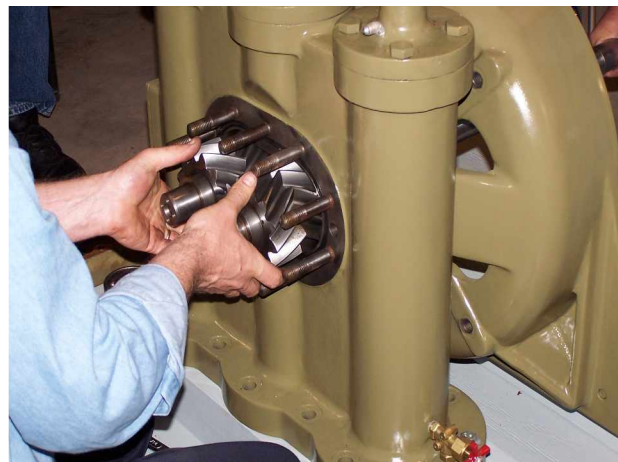
Woodward XX Herringbone Gear Pump

While this paper focuses on the Woodward XX Herringbone Gear Pump, the information presented here may be applied to almost any other style of pumping system. The unique herringbone gear design of the XX pump produced the high flow needed while reducing the output pressure pulses common to straight-cut gear designs. The XX pump features an internal check valve, internal pressure relief valve and an integral unloader system. The XX pump was manufactured in capacities up to 500 gallons per minute.

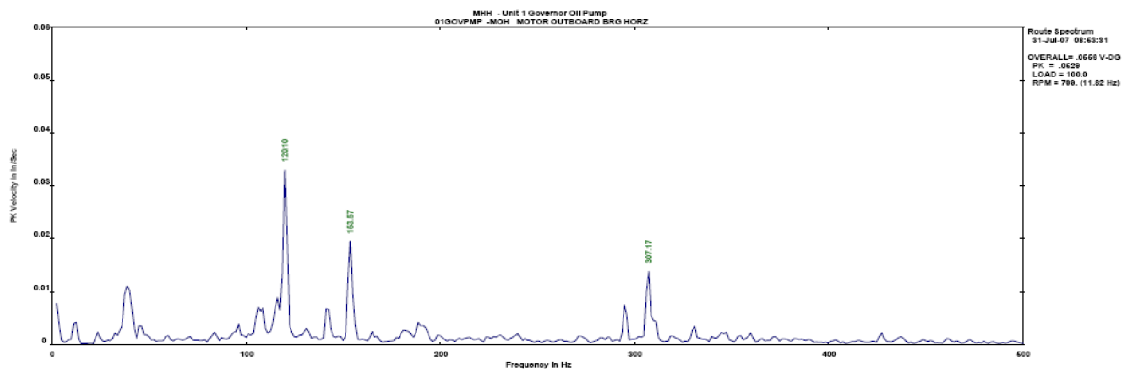
The following figures display the vibration data of a pump that we repaired in late 2007. Figure 1 data was taken a few months before failure. Figure 2 was taken after the repaired pump was placed back into service.

Equipment: (MNH) Unit 1 Governor Oil Pump
 Meas. Points: 01GOVPMP -MOM --> MOTOR OUTBOARD BRG HORZ
 Date/Time: 31-Jul-07 08:53:31 RPM= 11.82 Units=In/Sec PK

PEAK NO.	FREQUENCY (Hz)	PEAK VALUE	ORDER VALUE	PEAK NO.	FREQUENCY (Hz)	PEAK VALUE	ORDER VALUE
1	11.94	.0047	1.010	13	141.86	.0079	12.004
2	23.89	.0023	2.005	14	153.67	.0198	12.596
3	32.99	.0023	2.786	15	168.10	.0024	13.971
4	39.20	.0125	3.326	16	181.82	.0021	15.386
5	45.61	.0041	3.959	17	199.23	.0046	16.013
6	63.40	.0024	7.055	18	258.36	.0078	24.594
7	96.06	.0039	8.129	19	307.17	.0145	28.993
8	106.77	.0078	9.025	20	330.82	.0037	27.894
9	108.22	.0079	9.158	21	345.53	.0025	29.235
10	115.89	.0094	9.806	22	346.98	.0025	29.362
11	120.10	.0331	10.163	23	359.75	.0022	30.443
12	130.85	.0039	11.073	24	427.92	.0023	36.161

TOTAL MAG SUBSYNCHRONOUS SYNCHRONOUS NONSYNCHRONOUS
 .0454 0.0 / 0% .0281 / 34% .0212 / 19%
 (ELECTRICAL= .0391 / 47% FLOOR= .0151 SPEC CREST= 2.65)

Although the data above demonstrates some differences in amplitude and spectral peaks, there were no conclusive indicators to predict the unit was near failing. It is interesting to note, however, that the frequencies of the highest amplitude were 13 and 26 times the operating speed. This pump was provided with OEM recommended Double-Row, Max-Capacity bearings with 13 balls.

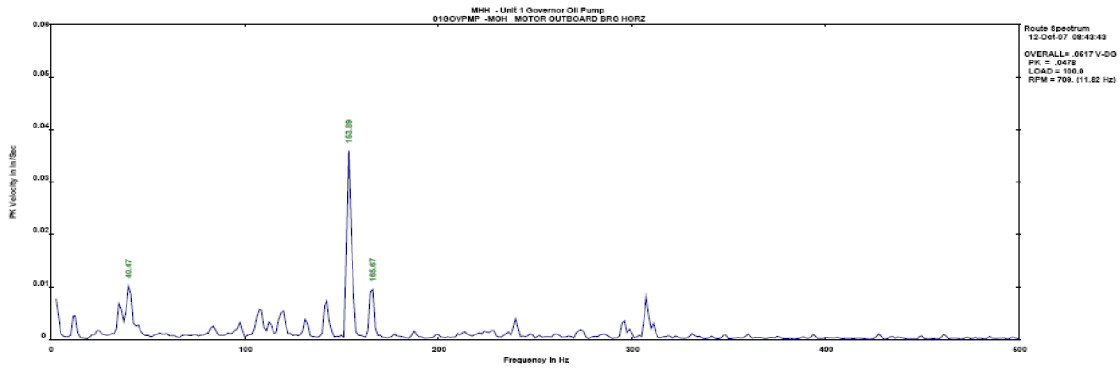
Figure 2

Equipment: (MNH) Unit 1 Governor Oil Pump
 Meas. Points: 01GOVPMP -MOM --> MOTOR OUTBOARD BRG HORZ
 Date/Time: 12-Oct-07 08:43:43 RPM= 11.82 Units=In/Sec PK

PEAK NO.	FREQUENCY (Hz)	PEAK VALUE	ORDER VALUE	PEAK NO.	FREQUENCY (Hz)	PEAK VALUE	ORDER VALUE
1	11.99	.0093	1.006	13	153.89	.0262	12.023
2	24.34	.0020	2.060	14	165.67	.0110	14.020
3	38.94	.0076	2.999	15	187.94	.0016	16.879
4	40.47	.0111	3.425	16	221.25	.0016	18.723
5	44.45	.0082	3.761	17	224.06	.0018	18.978
6	51.27	.0028	7.046	18	228.19	.0020	19.305
7	97.32	.0039	8.295	19	240.05	.0040	20.314
8	108.10	.0066	9.148	20	273.24	.0020	23.122
9	112.94	.0036	9.887	21	298.77	.0099	26.029
10	119.44	.0062	10.197	22	298.46	.0020	25.256
11	131.64	.0041	11.140	23	307.61	.0052	26.031
12	141.99	.0081	12.018	24	310.98	.0092	26.316

TOTAL MAG SUBSYNCHRONOUS SYNCHRONOUS NONSYNCHRONOUS
 .0445 0.0 / 0% .0402 / 82% .0184 / 17%
 (ELECTRICAL= .0040 / 1% FLOOR= .0141 SPEC CREST= 2.37)

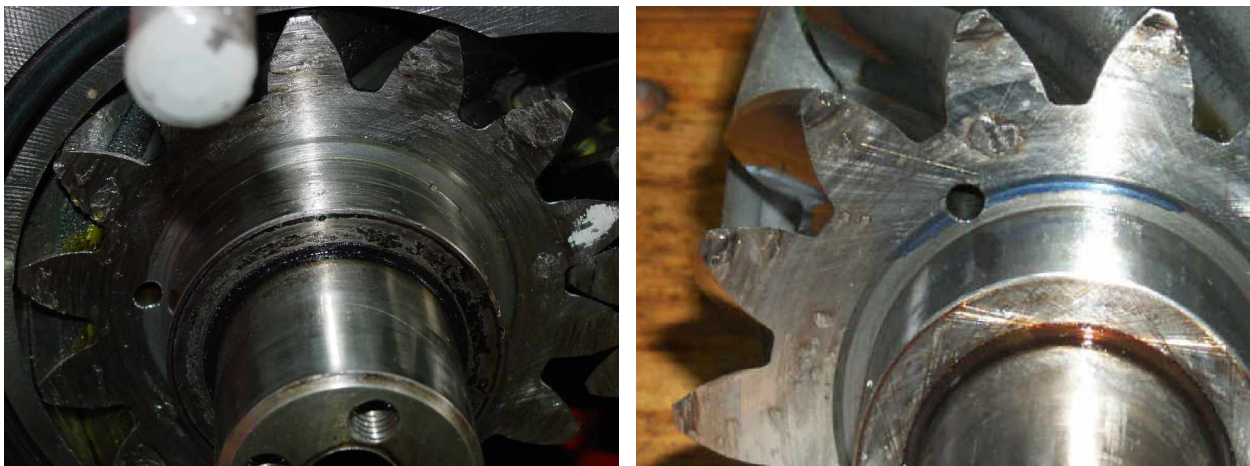
As shaft bearings begin to fail, critical alignment suffers and if left unattended can result in extreme damage to shafts, gears, wear plates, as well as pump casting damage that is very difficult to address.

The most common result of bearing failure is galling, defined as: “A condition whereby excessive friction between high spots results in localized welding with subsequent splitting and a further roughening of rubbing surfaces of one or both of two mating parts”

Figure 3 - Pump Gear Damage

The *gear damage* shown in the photos above (*Figure 3*) can be repaired, but the picked-up metal is 'work-hardened', and is extremely difficult to remove. Bearing *wear plate* damage (*Figure 4*) is more easily resurfaced, but both of these repairs can change the geometry of the pump, and critical tolerances. In the process of repair, several factors must be considered such as end clearance, gear apex centering, (magnetic) motor centering, and in some cases depth of the O-Ring groove.

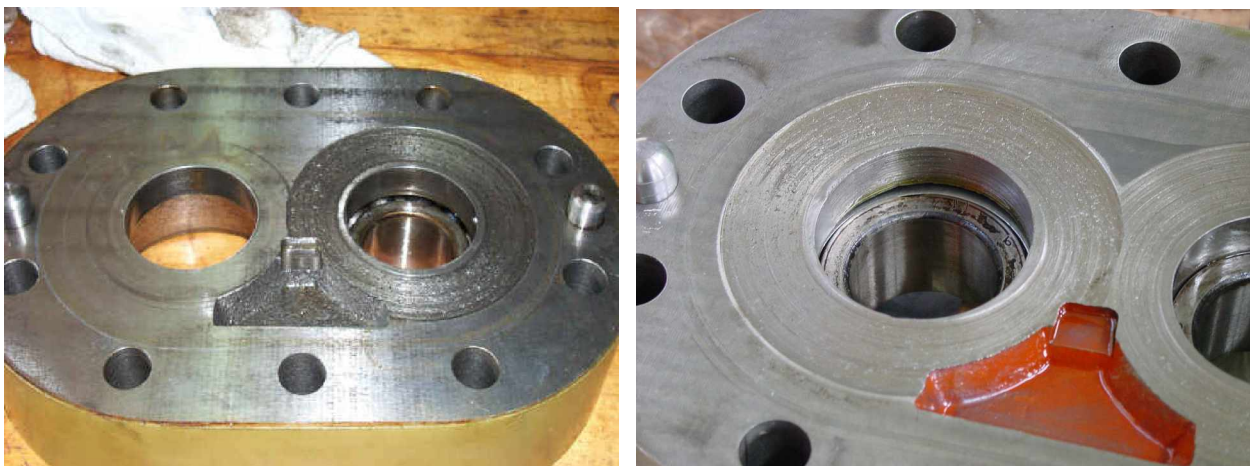
Figure 4 - Bearing Wear Plate Damage

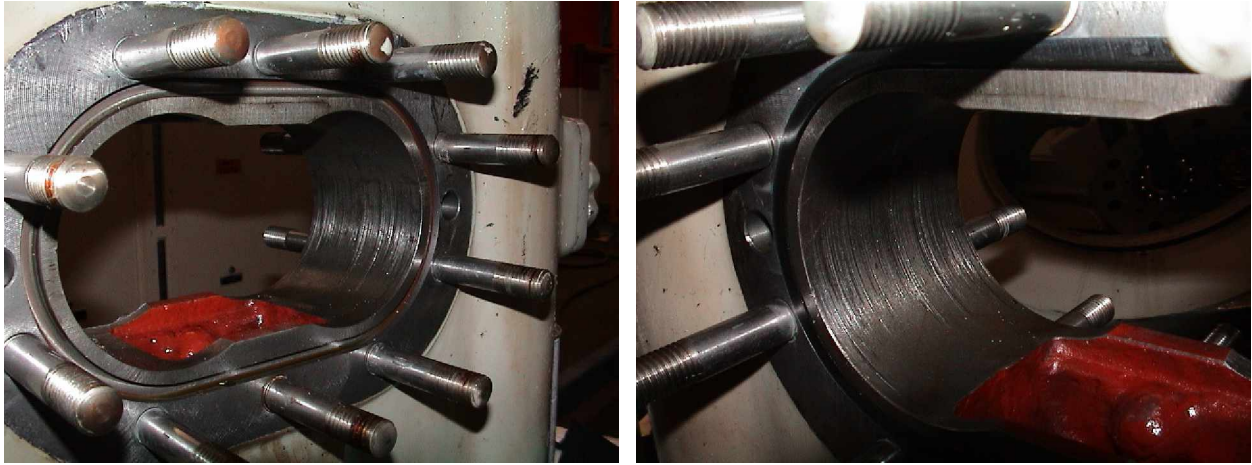
Figure 5 - Pump Gear Pocket Damage

Severe gear *pocket damage* (*Figure 4*) is almost always fatal to the pump. Since these are Positive-Displacement pumps and depend on a close gear to pocket clearance, deep scoring in this area will often prevent the pump from ever priming or building pressure.

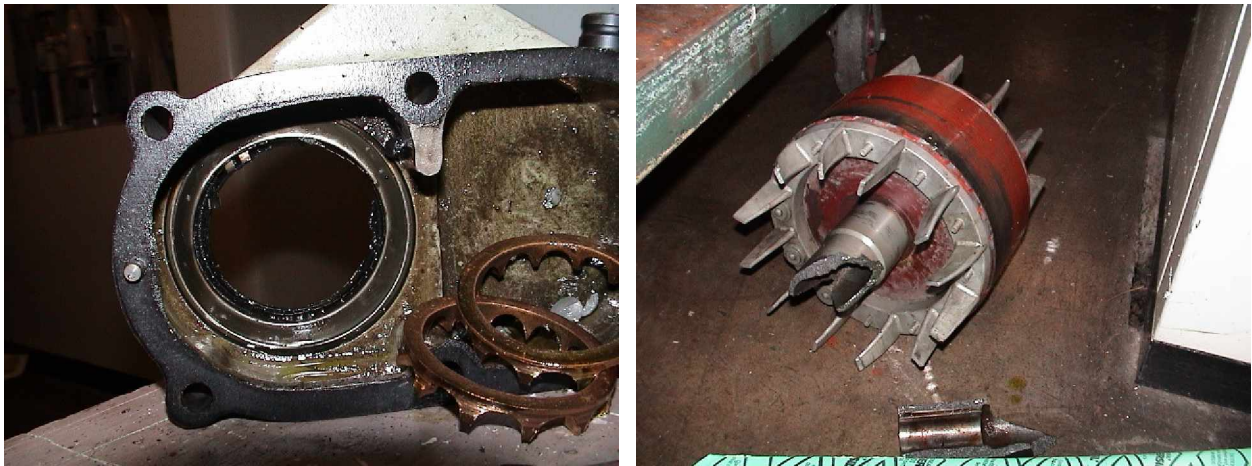
Figure 6 - this pump stopped, the rotor didn't

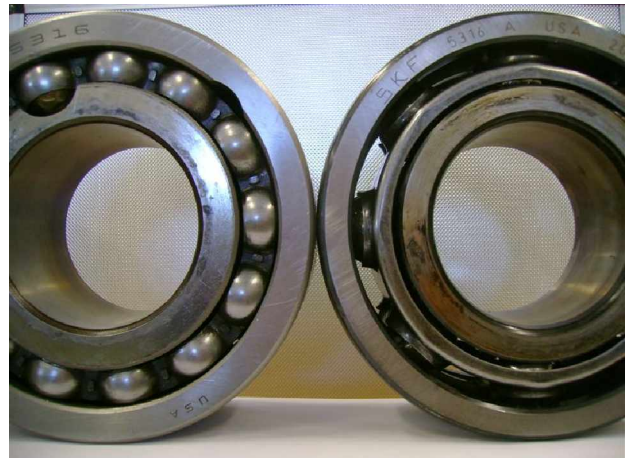
The bearing on the right is a standard duty bearing with 8 balls. The bearing on the left is a maximum capacity bearing with 13 balls. The difference in load carrying capacity is clear.

The **correct** replacement bearings and parts must always be used for overhauls. For example, only Maximum Capacity open bearings should be used.
